2019 Data Report for Diamond Lake, Newaygo County

Site ID: 620035

Diamond Lake, Newaygo County 2019 CLMP Results

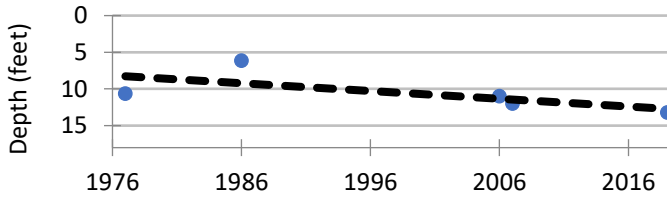
Secchi Disk Transparency (feet)

Year	# Readings	Min	Max	Average	Std. Dev	Carlson TSI
2019	9	11.0	16.0	13.2	1.7	40
1977-2007	52	6.0	15.5	9.9	1.5	44
2019 All CLMP Lakes	3392	1.5	50.0	12.8	5.8	42

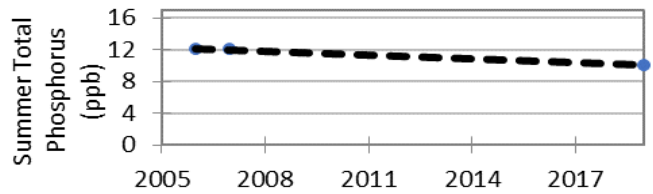
Summer Phosphorus (parts per billion)

Year	# Samples	Min	Max	Average	Std. Dev	Carlson TSI
2019	1	10.0	10.0	10.0	NA	37
2006-2007	2	12.0	12.0	12.0	0.0	40
2019 All CLMP Lakes	281	<= 3	65.0	12.8	9.3	38

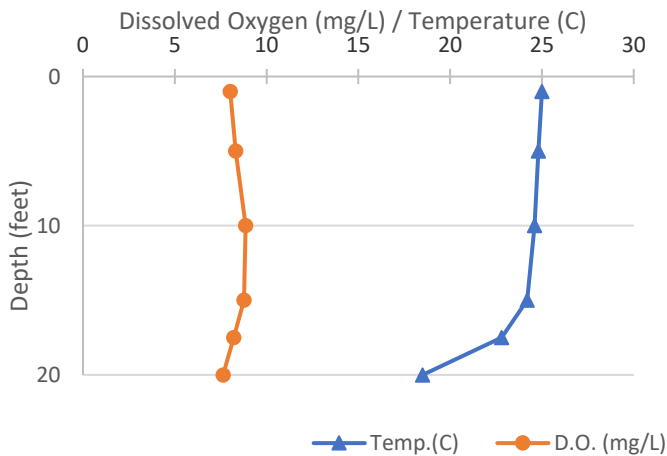
8/20/2019

Dissolved Oxygen and Temperature Profile

The low level of nutrients in the lake results in dissolved oxygen being available throughout the water column for the entire summer.

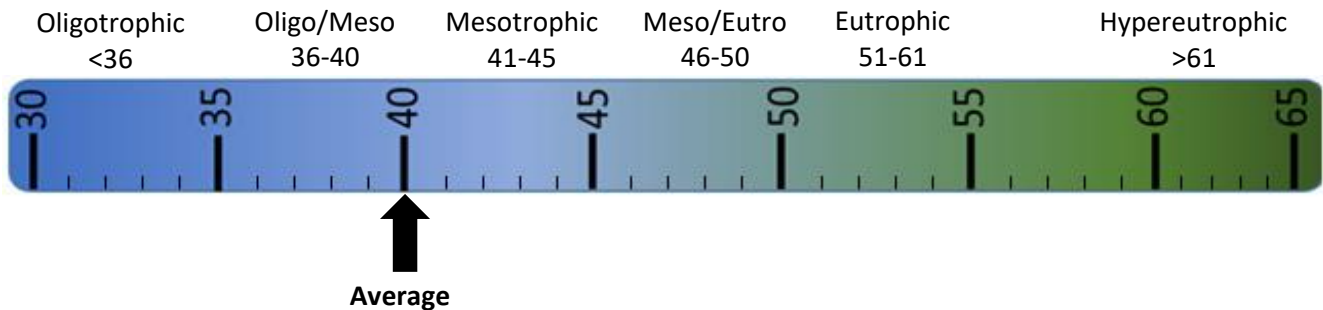
TSI for Diamond Lake in 2019	
Average	40
Secchi Disk	40
Summer TP	37
Chlorophyll-a	41

Oligotrophic: Generally deep and clear lakes with little aquatic plant or algae growth. These lakes maintain sufficient dissolved oxygen in the cool, deep-bottom waters during late summer to support cold water fish, such as trout and whitefish.

Mesotrophic: Lakes that fall between oligotrophic and eutrophic. Mid-ranged amounts of nutrients.

Eutrophic: Highly productive eutrophic lakes are generally shallow, turbid, and support abundant aquatic plant growth. In deep eutrophic lakes, the cool bottom waters usually contain little or no dissolved oxygen. Therefore, these lakes can only support warm water fish, such as bass and pike.

Hypereutrophic: A specialized category of eutrophic lakes. These lakes exhibit extremely high productivity, such as nuisance algae and weed growth.

In 1977, limnologist Dr. Robert Carlson developed a numerical scale (0-100) where the numbers indicate the level of nutrient enrichment. Using the proper equations, we can convert results from Summer Total Phosphorus, Secchi Depth, and Chlorophyll-a to this Trophic Status Index (TSI). The TSI numbers are furthermore grouped into general categories (oligotrophic, mesotrophic, eutrophic, and hypereutrophic), to quickly give us a way to understand the general nutrient level of any lake.

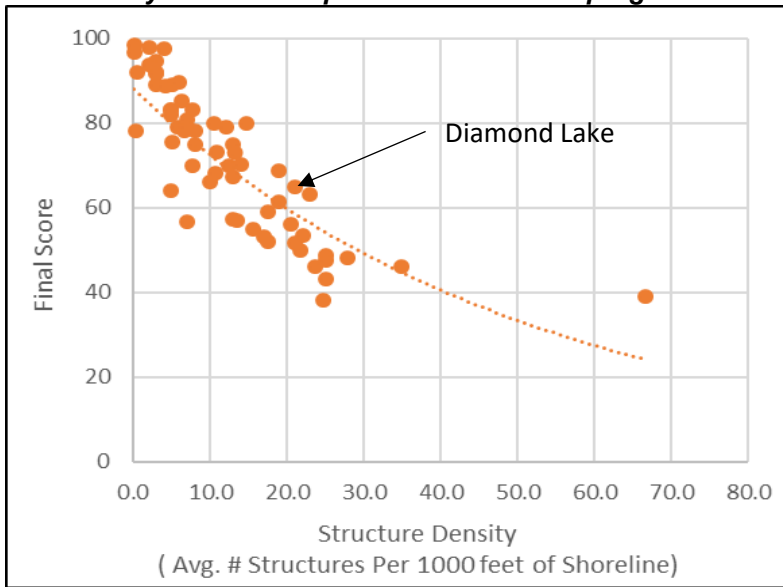
How does your lake compare to others in the program?

Diamond Lake:	
Number of Sections:	16
Number of Structures:	341
Structure Density:	21
Final Score:	65

All 63 Participating Lakes from 2015-2019:	
Avg. Number of Sections:	16
Avg. Number of Structures:	226
Avg. Structure Density:	12.5
Avg. Final Score:	71.1

Overall, the lakeshore habitat of Diamond Lake scored slightly lower when average when compared to other lakes in the program, but probably scored exactly as expected considering the amount of development along the shores.

The lake sections scored highest for erosion control, with an average of 82, meaning that there are a low amount of sea walls, rock rip-rap, and other shoreline erosion structures.

The littoral zone and riparian zone was the weak point in Diamond Lake's habitat (scoring an average of 58 and 54). To improve the littoral zone score, leave woody debris in place and allow native aquatic vegetation to grow in the shallow waters. To boost the riparian score, reduce the amount of mowed grass and increase the amount of unmowed native vegetation along the lakeshore to boost this aspect of the shoreline habitat.

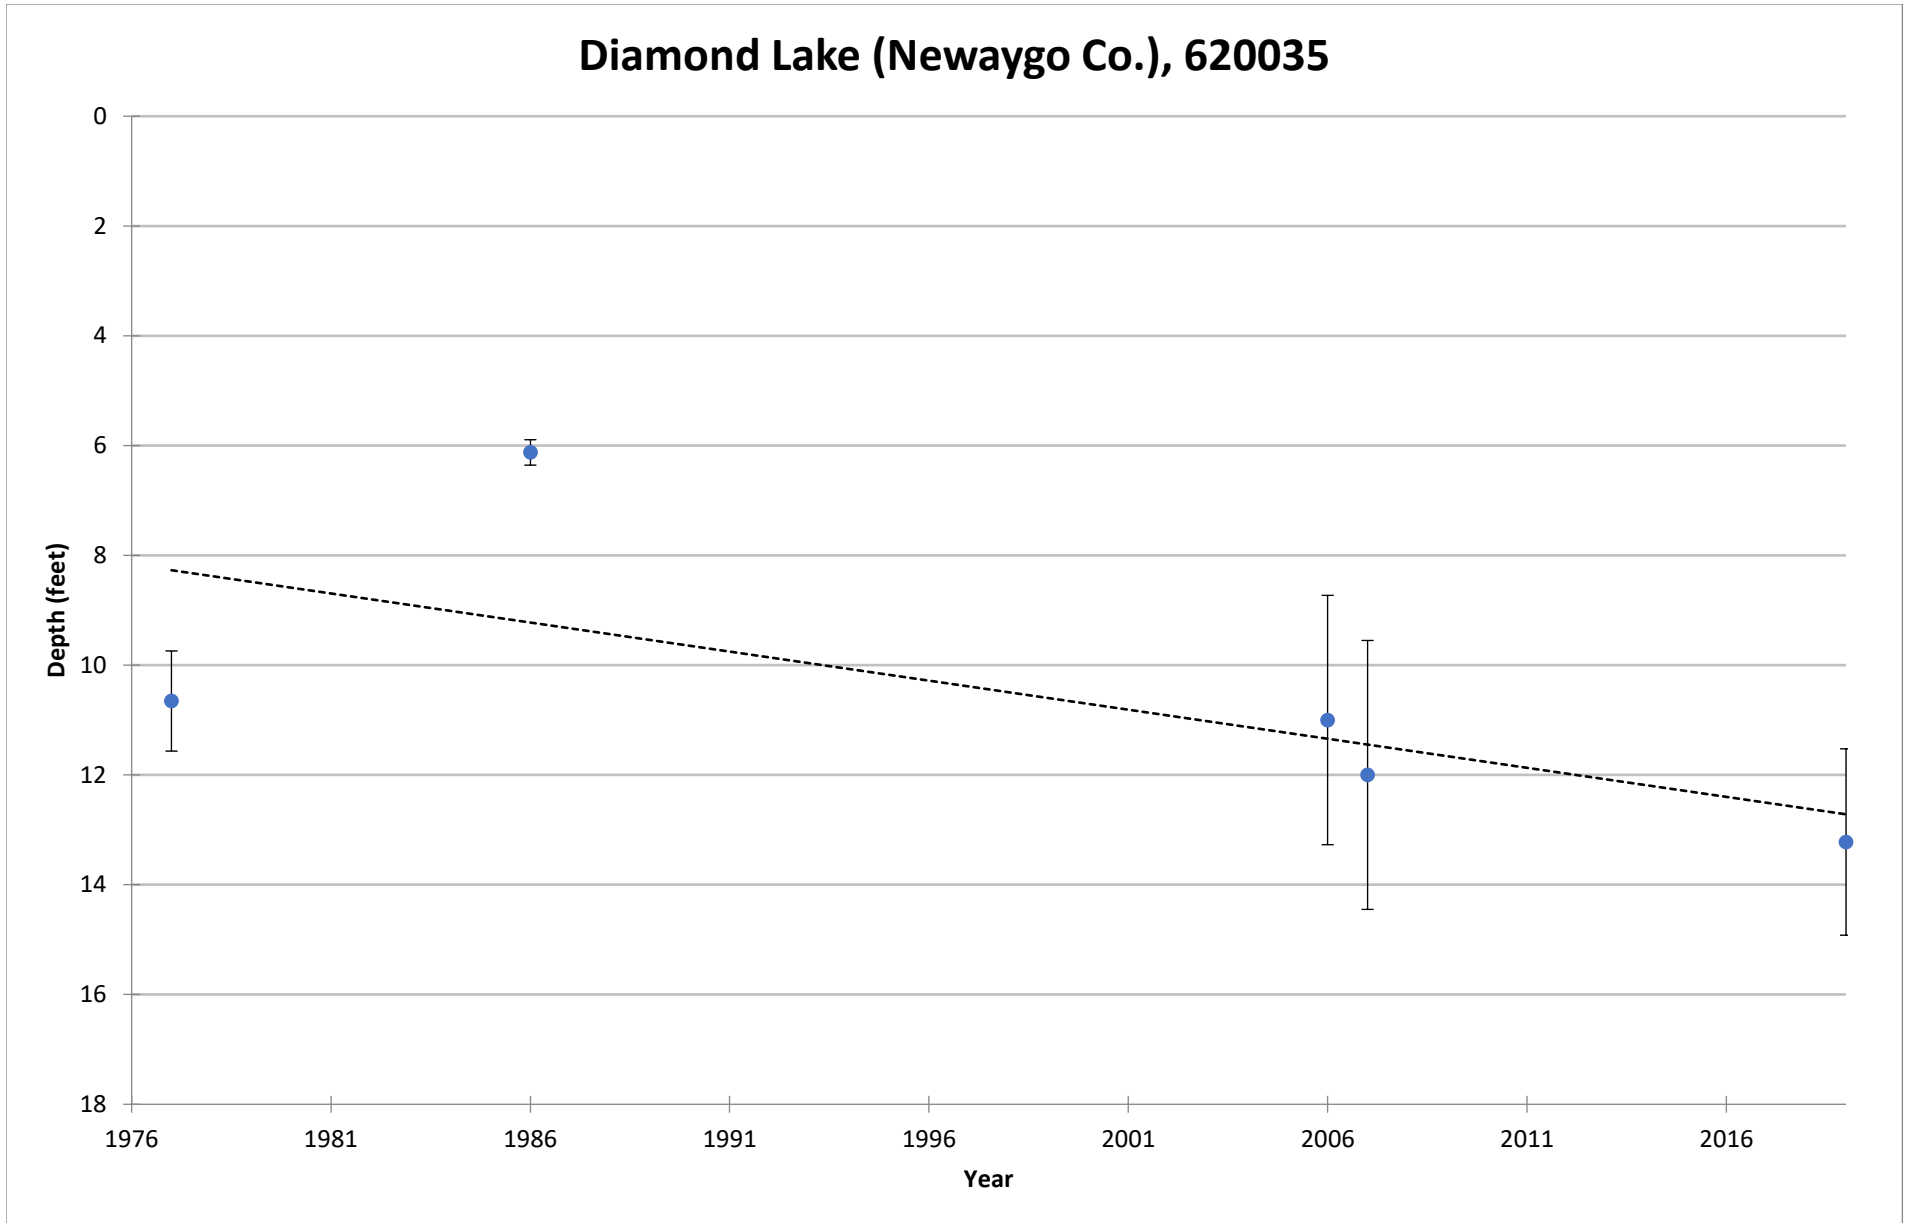
Diamond Lake (Newaygo Co.), 620035

COOPERATIVE LAKES MONITORING PROGRAM
SUMMER MEAN TRANSPARENCY

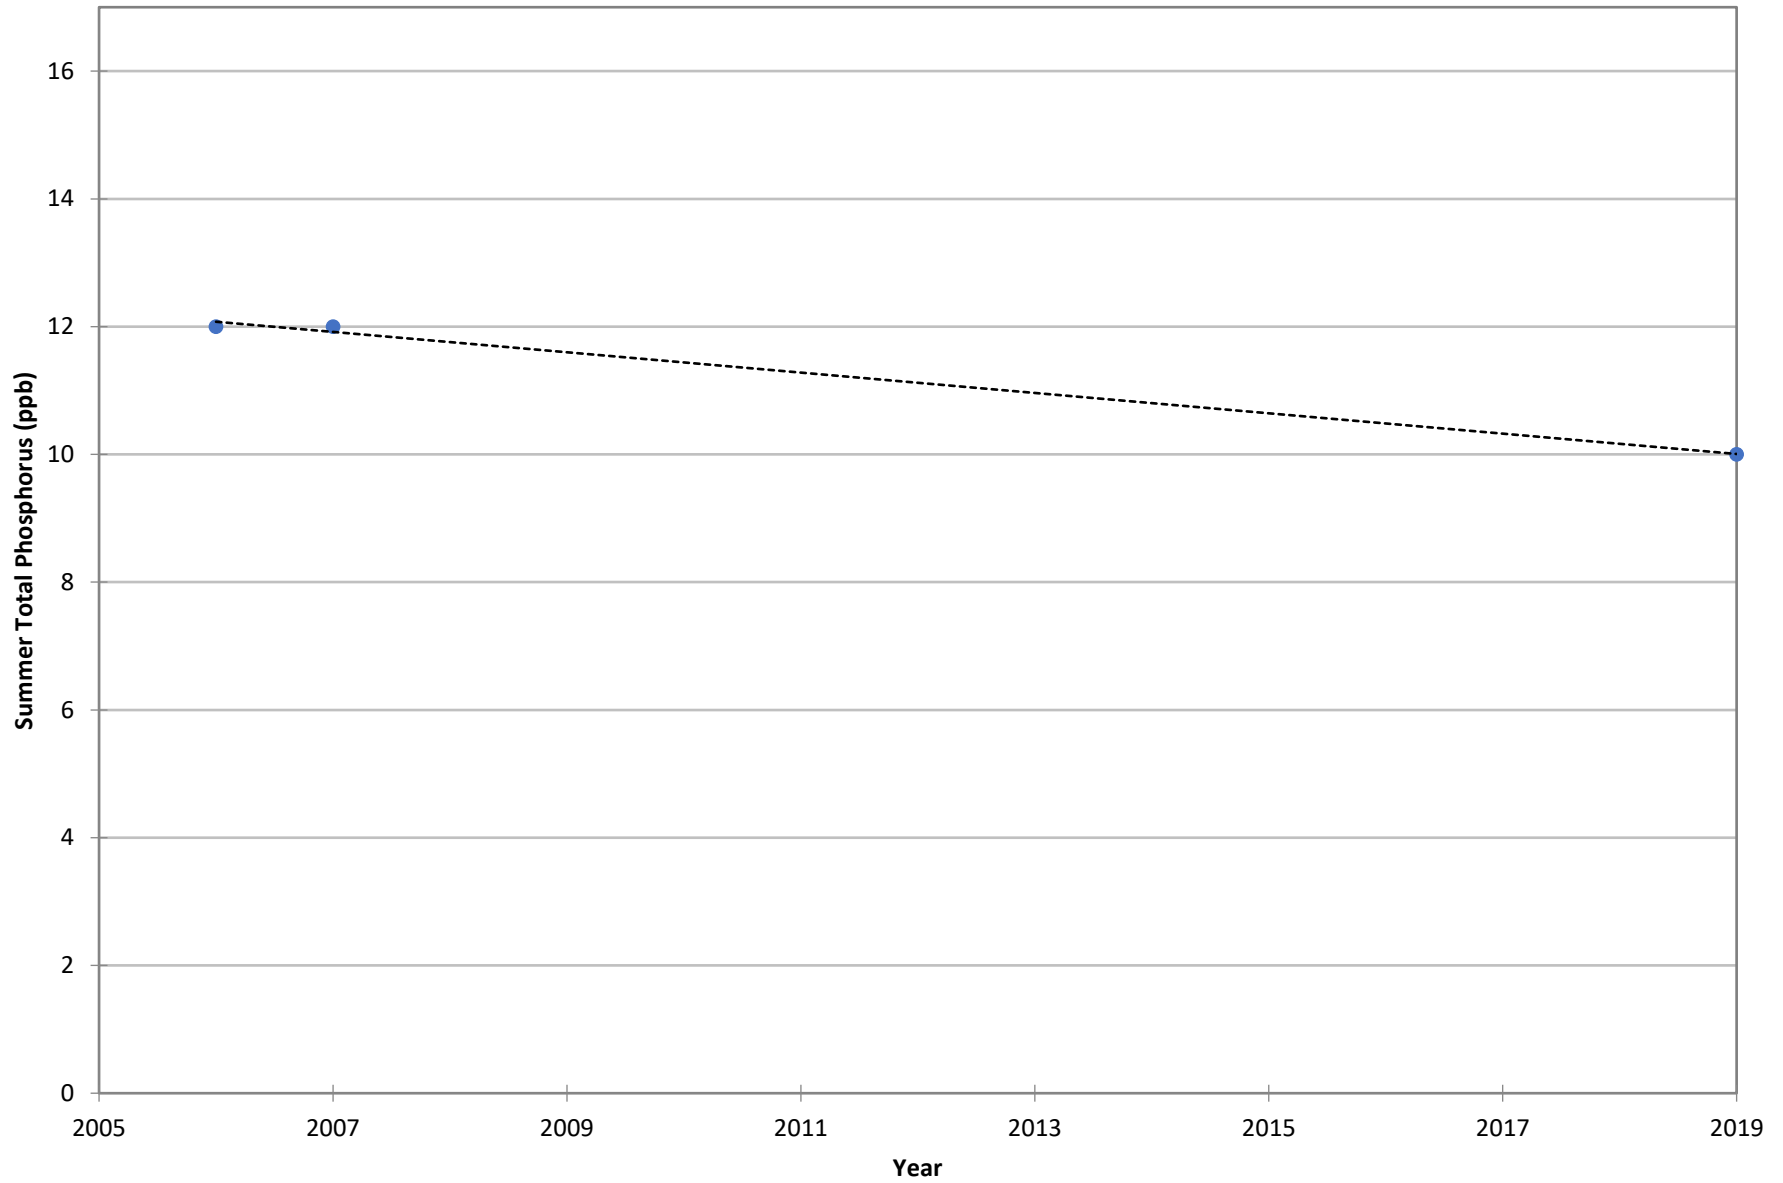
Diamond Lake (Newaygo Co.), 620035

Vertical bars indicate standard deviation

COOPERATIVE LAKES MONITORING PROGRAM
SUMMER TOTAL PHOSPHORUS

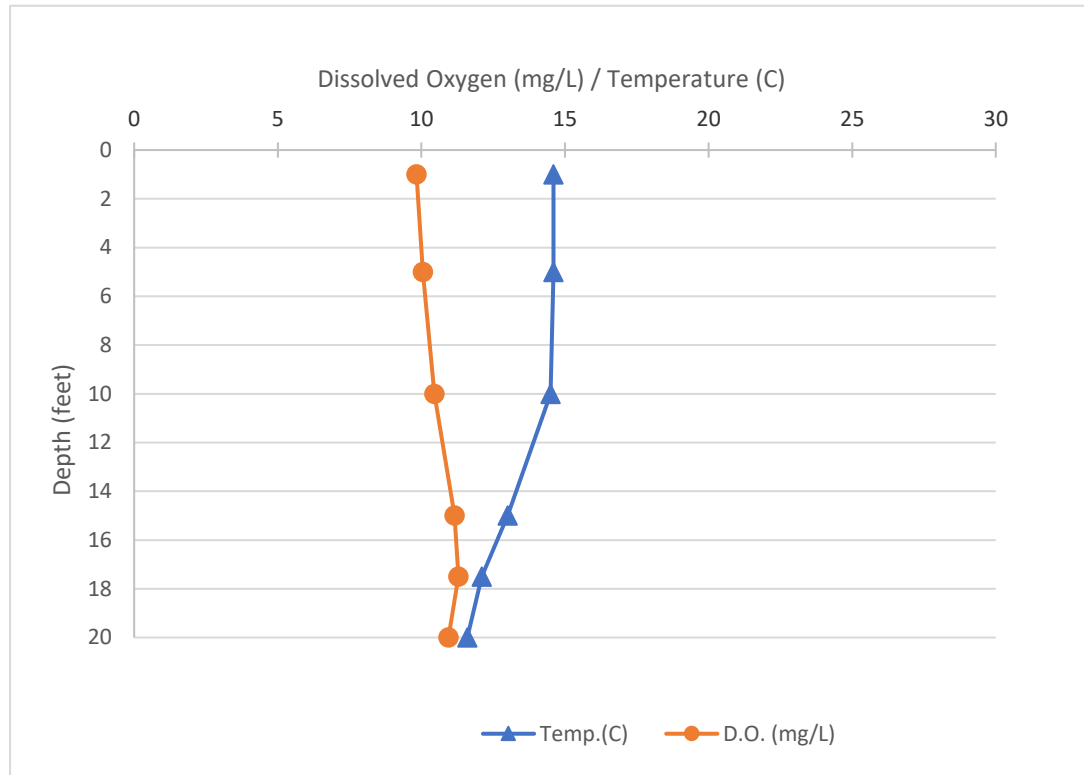
5/17/2019

Dissolved Oxygen and Temperature Profile

Depth (ft)	Temp.(C)	D.O. (mg/L)
1	14.6	9.83
5	14.6	10.05
10	14.5	10.45
15	13	11.15
17.5	12.1	11.29
20	11.6	10.94

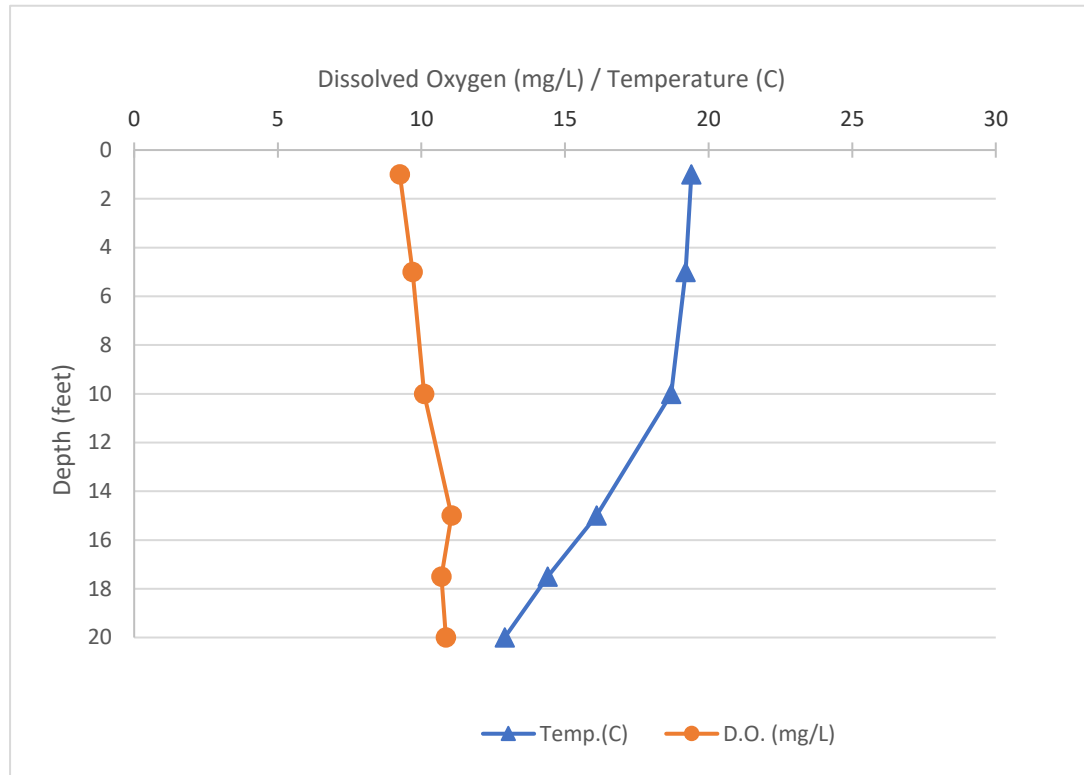
6/1/2019

Dissolved Oxygen and Temperature Profile

Depth (ft)	Temp.(C)	D.O. (mg/L)
1	19.4	9.25
5	19.2	9.7
10	18.7	10.1
15	16.1	11.05
17.5	14.4	10.7
20	12.9	10.86

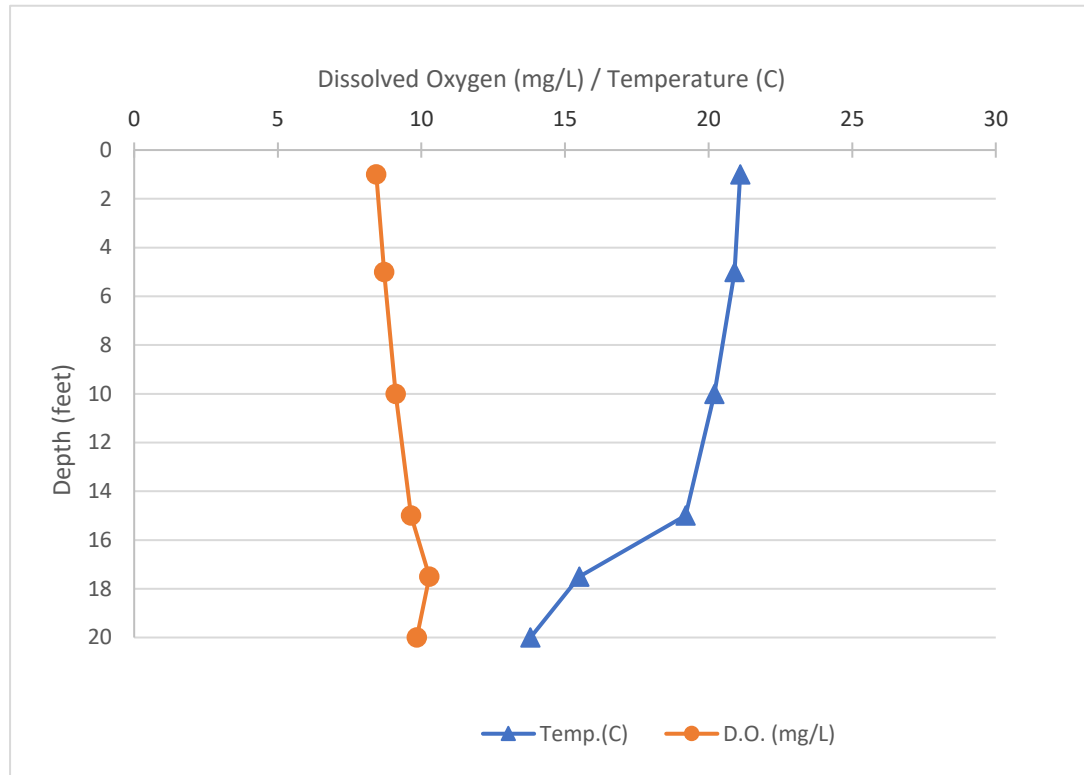
6/11/2019

Dissolved Oxygen and Temperature Profile

Depth (ft)	Temp.(C)	D.O. (mg/L)
1	21.1	8.43
5	20.9	8.7
10	20.2	9.1
15	19.2	9.64
17.5	15.5	10.28
20	13.8	9.84

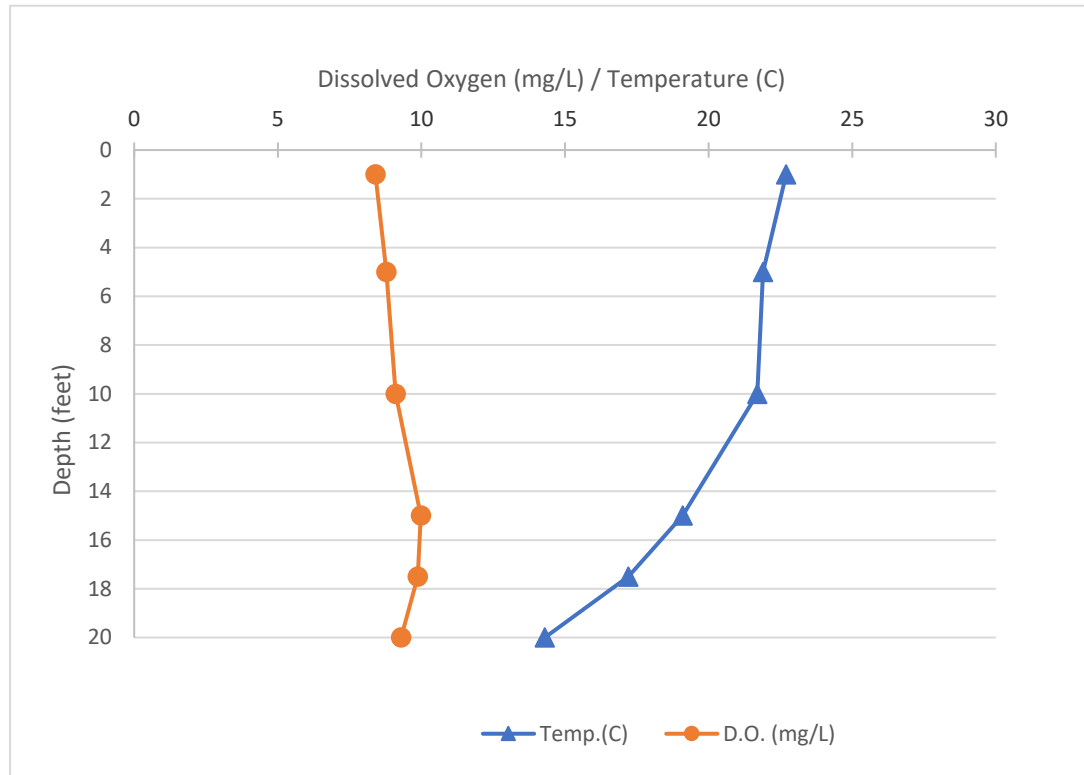
6/26/2019

Dissolved Oxygen and Temperature Profile

Depth (ft)	Temp.(C)	D.O. (mg/L)
1	22.7	8.4
5	21.9	8.78
10	21.7	9.11
15	19.1	9.98
17.5	17.2	9.87
20	14.3	9.3

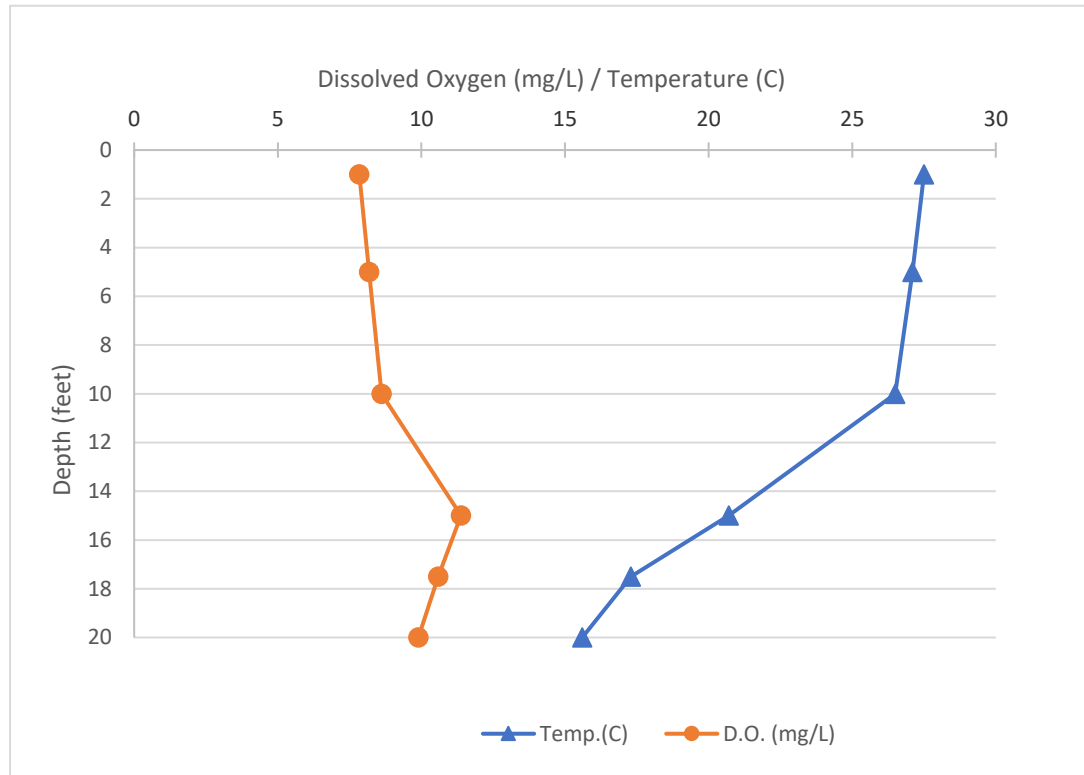
7/16/2019

Dissolved Oxygen and Temperature Profile

Depth (ft)	Temp.(C)	D.O. (mg/L)
1	27.5	7.84
5	27.1	8.18
10	26.5	8.62
15	20.7	11.38
17.5	17.3	10.59
20	15.6	9.9

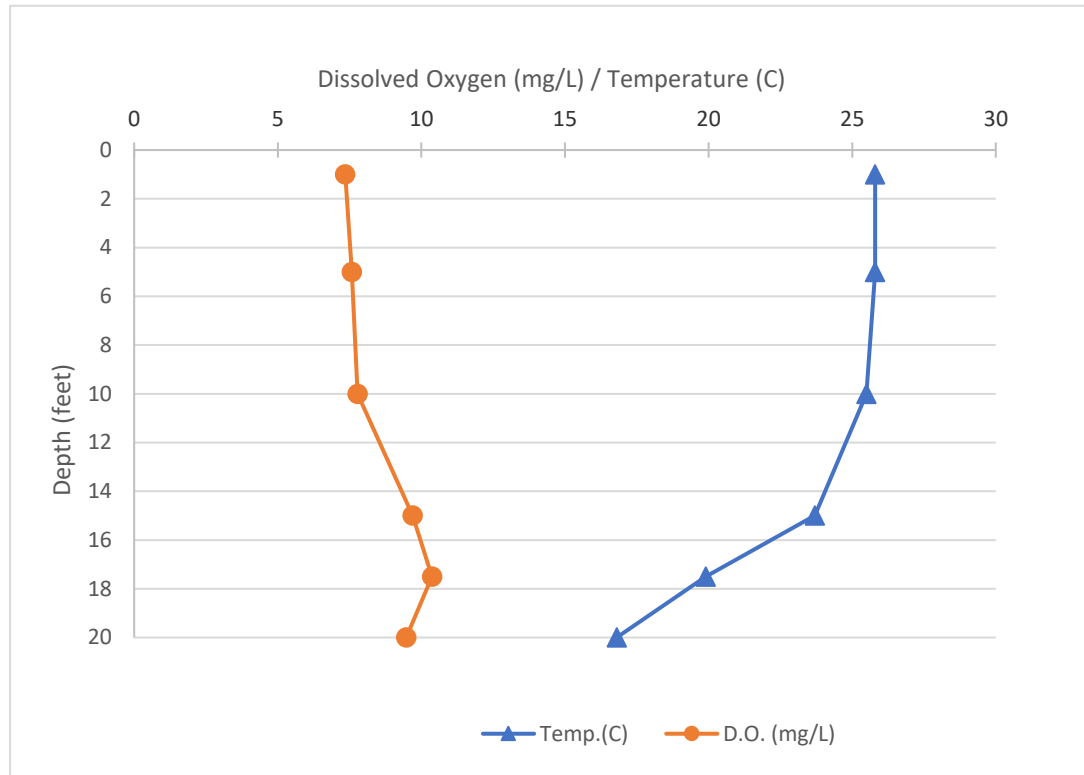
7/30/2019

Dissolved Oxygen and Temperature Profile

Depth (ft)	Temp.(C)	D.O. (mg/L)
1	25.8	7.35
5	25.8	7.58
10	25.5	7.78
15	23.7	9.7
17.5	19.9	10.37
20	16.8	9.47

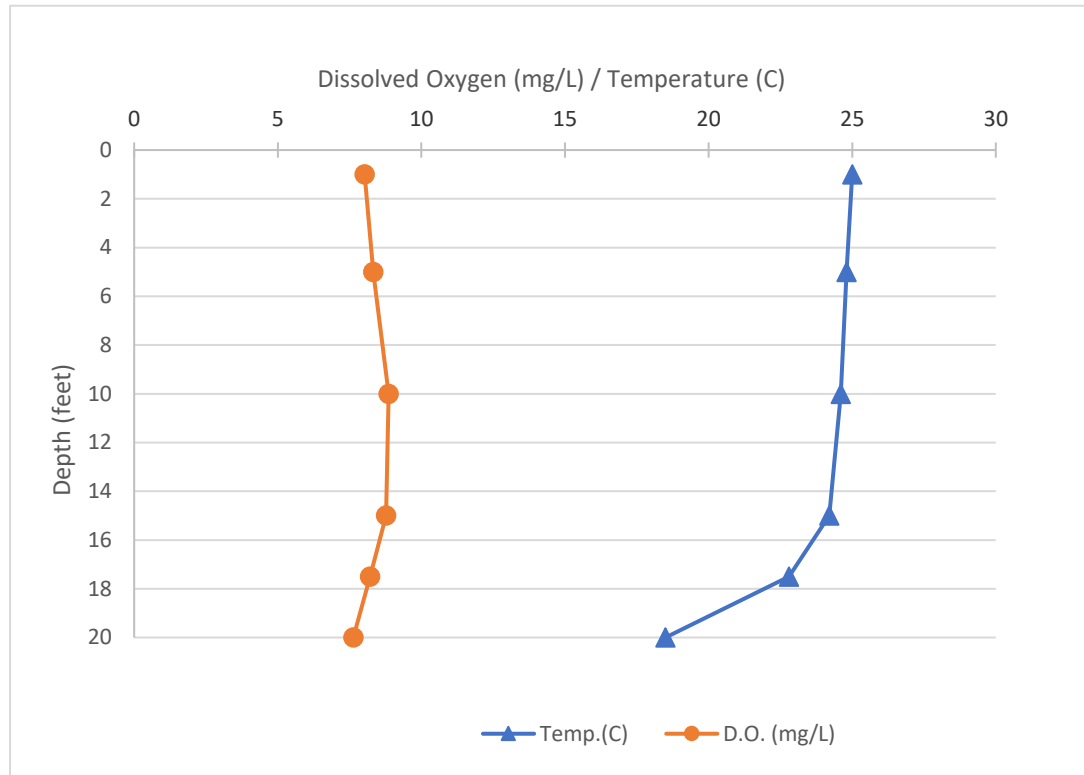
8/20/2019

Dissolved Oxygen and Temperature Profile

Depth (ft)	Temp.(C)	D.O. (mg/L)
1	25	8.02
5	24.8	8.32
10	24.6	8.86
15	24.2	8.77
17.5	22.8	8.21
20	18.5	7.63

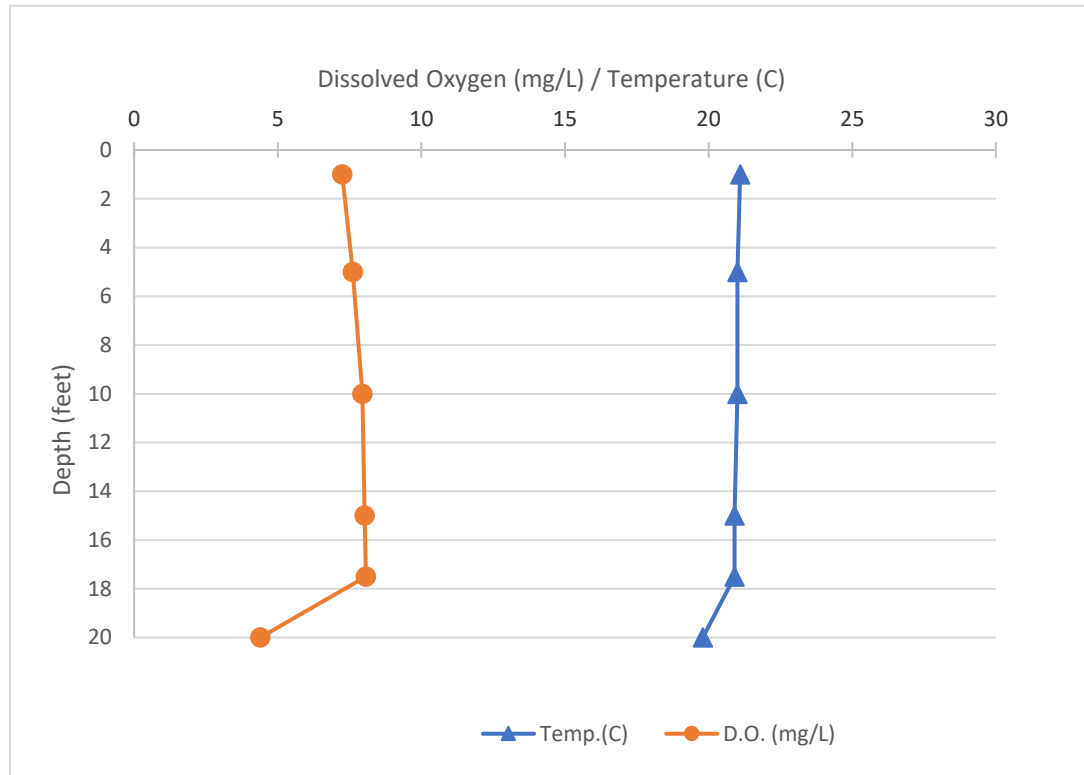
9/5/2019

Dissolved Oxygen and Temperature Profile

Depth (ft)	Temp.(C)	D.O. (mg/L)
1	21.1	7.25
5	21	7.61
10	21	7.95
15	20.9	8.02
17.5	20.9	8.07
20	19.8	4.39

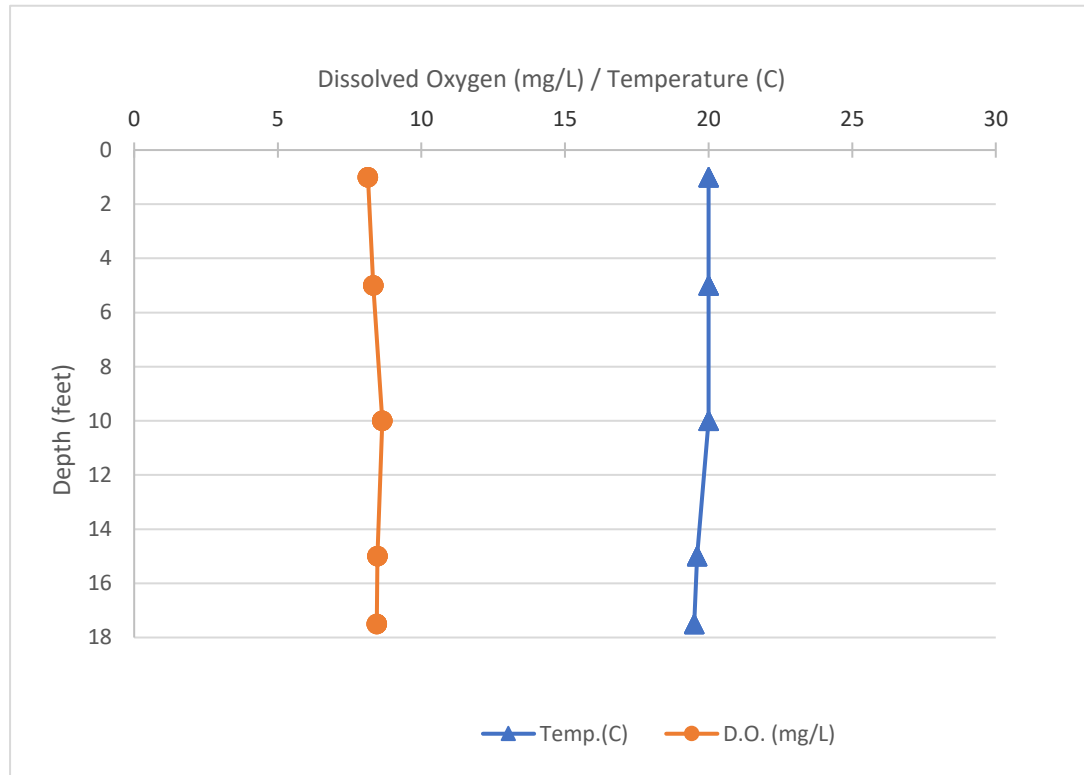
9/12/2019

Dissolved Oxygen and Temperature Profile

Depth (ft)	Temp.(C)	D.O. (mg/L)
1	20	8.14
1	20	8.14
1	20	8.14
1	20	8.14
5	20	8.33
5	20	8.33
5	20	8.33
5	20	8.33
10	20	8.64
10	20	8.64
10	20	8.64
10	20	8.64
15	19.6	8.47
15	19.6	8.47
15	19.6	8.47
15	19.6	8.47
17.5	19.5	8.45
17.5	19.5	8.45
17.5	19.5	8.45
17.5	19.5	8.45
