2019 Data Report for Turtle Lake, Benzie County

Site ID: 100140

Turtle Lake, Benzie County 2019 CLMP Results

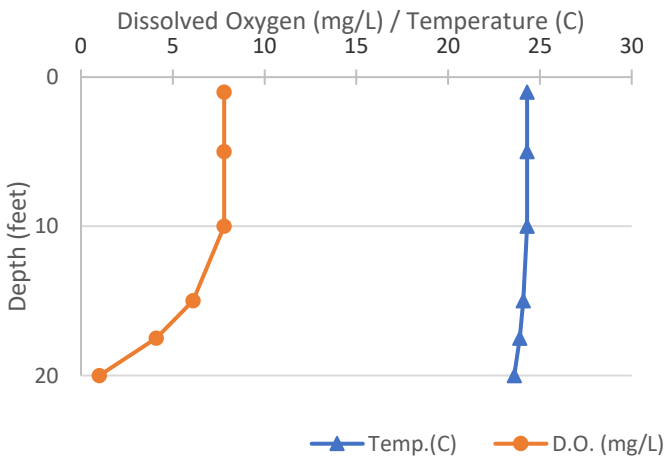
8/15/2019

Dissolved Oxygen and Temperature Profile

Due to its low depth, the lake is able to maintain dissolved oxygen throughout the water column for the entire summer, though there are days when dissolved oxygen gets low or anoxic on the bottom waters.

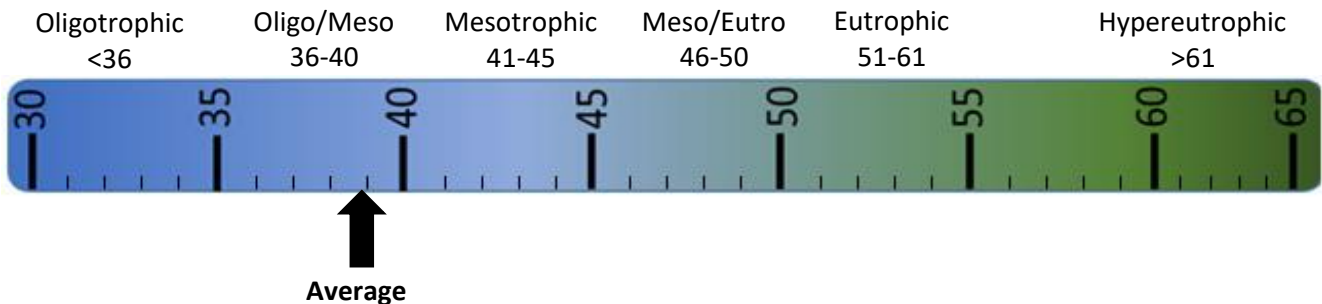
With an average TSI score of 39 based on 2019 Secchi transparency, chlorophyll-a, and summer total phosphorus data, this lake is rated between the oligotrophic and mesotrophic lake classification. The lake leans slightly more mesotrophic than oligotrophic.

TSI for Turtle Lake in 2019	
Average	39
Secchi Disk	39
Summer TP	37
Chlorophyll-a	39

In 1977, limnologist Dr. Robert Carlson developed a numerical scale (0-100) where the numbers indicate the level of nutrient enrichment. Using the proper equations, we can convert results from Summer Total Phosphorus, Secchi Depth, and Chlorophyll-a to this Trophic Status Index (TSI). The TSI numbers are furthermore grouped into general categories (oligotrophic, mesotrophic, eutrophic, and hypereutrophic), to quickly give us a way to understand the general nutrient level of any lake.

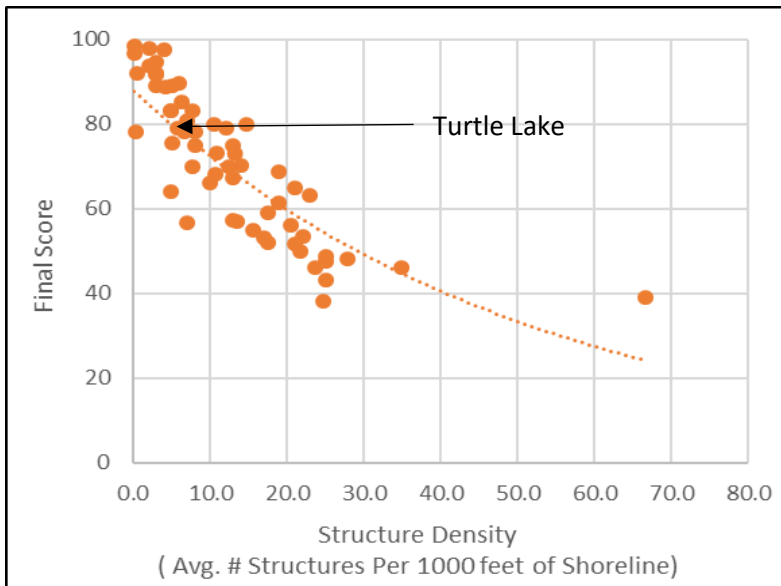
How does your lake compare to others in the program?

Turtle Lake:	
Number of Sections:	9
Number of Structures:	64
Structure Density:	7
Final Score:	79

All 62 Participating Lakes from 2015-2019:	
Avg. Number of Sections:	16
Avg. Number of Structures:	228
Avg. Structure Density:	12.6
Avg. Final Score:	71

Overall, the lakeshore habitat of Turtle Lake is doing well and scored slightly higher than average when compared to other lakes in the program. All of the 1000 foot sections scored either Fair or Good: 2 fair, and 7 good.

The littoral zone was the weak point in Turtle Lake’s habitat (scoring an average of 69). A score of 69 is not bad, but if residents want to improve the overall shoreline quality, this is the component to concentrate on. To improve the littoral zone score, leave woody debris in place and allow native aquatic vegetation to grow in the shallow waters.

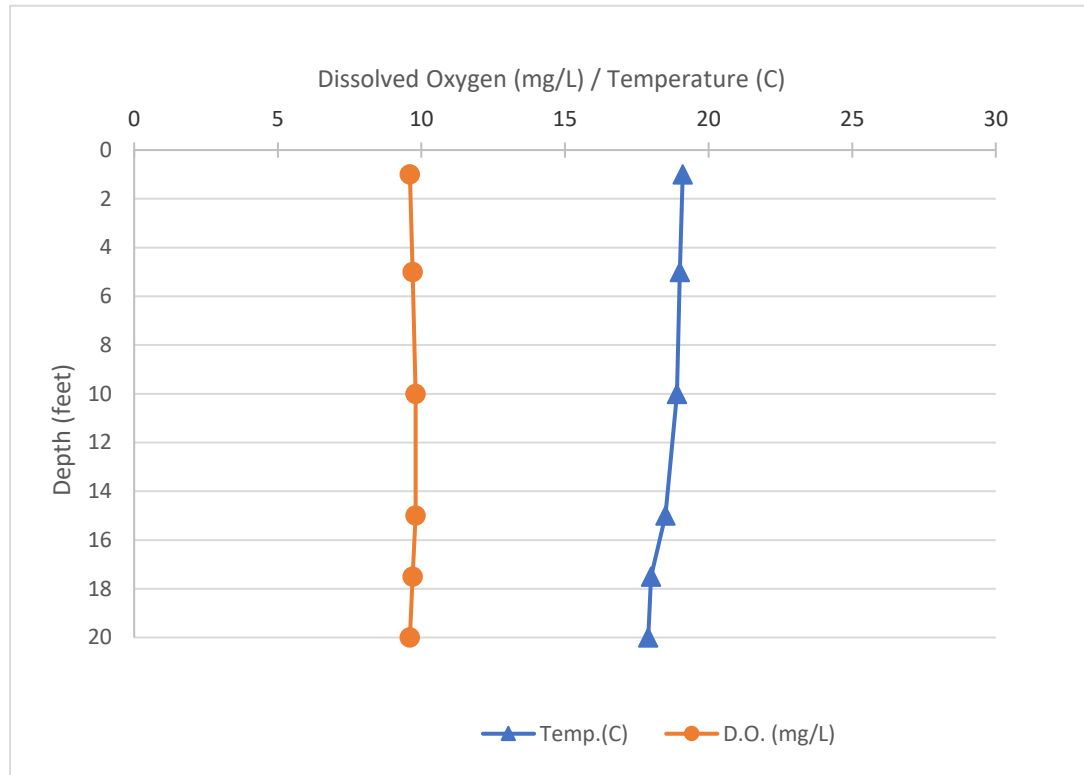
6/14/2019

Dissolved Oxygen and Temperature Profile

Depth (ft)	Temp.(C)	D.O. (mg/L)
1	19.1	9.6
5	19	9.7
10	18.9	9.8
15	18.5	9.8
17.5	18	9.7
20	17.9	9.6

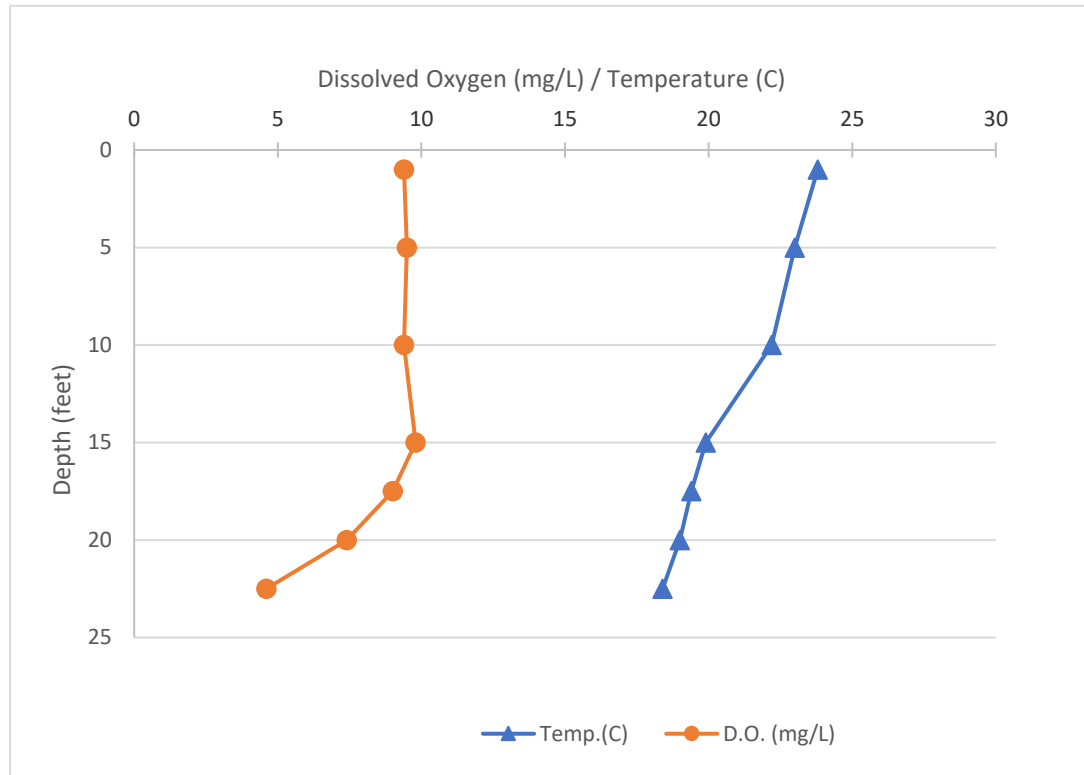
6/26/2019

Dissolved Oxygen and Temperature Profile

Depth (ft)	Temp.(C)	D.O. (mg/L)
1	23.8	9.4
5	23	9.5
10	22.2	9.4
15	19.9	9.8
17.5	19.4	9
20	19	7.4
22.5	18.4	4.6

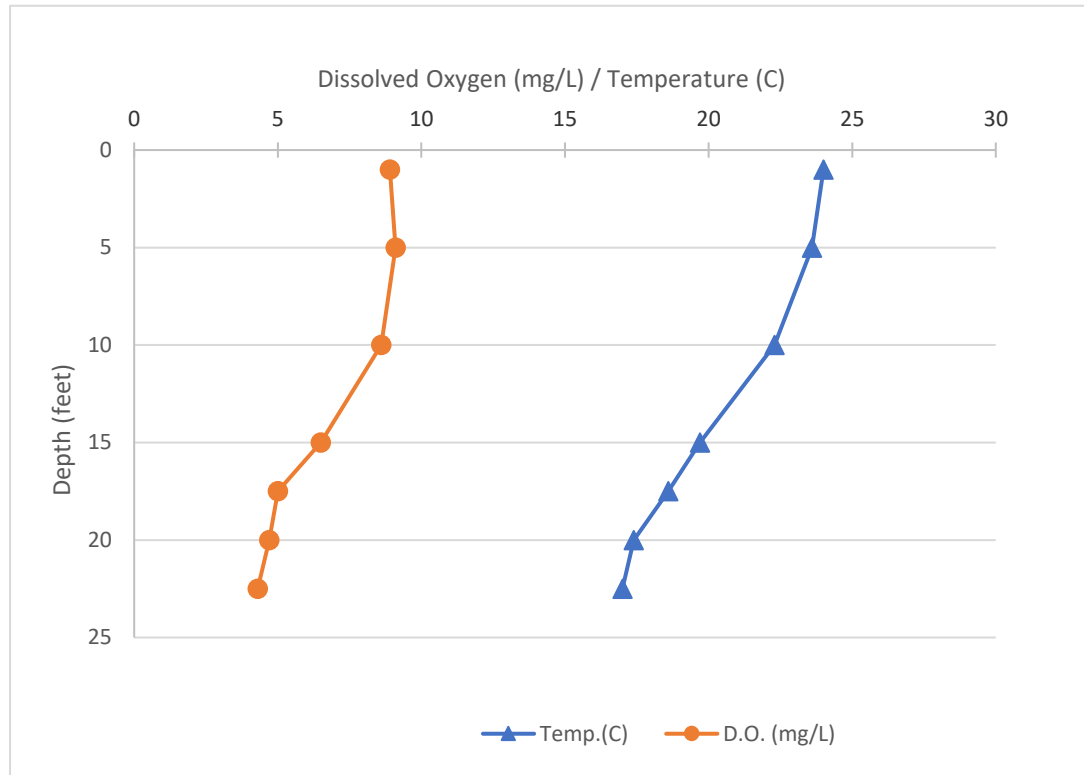
7/15/2019

Dissolved Oxygen and Temperature Profile

Depth (ft)	Temp.(C)	D.O. (mg/L)
1	24	8.9
5	23.6	9.1
10	22.3	8.6
15	19.7	6.5
17.5	18.6	5
20	17.4	4.7
22.5	17	4.3

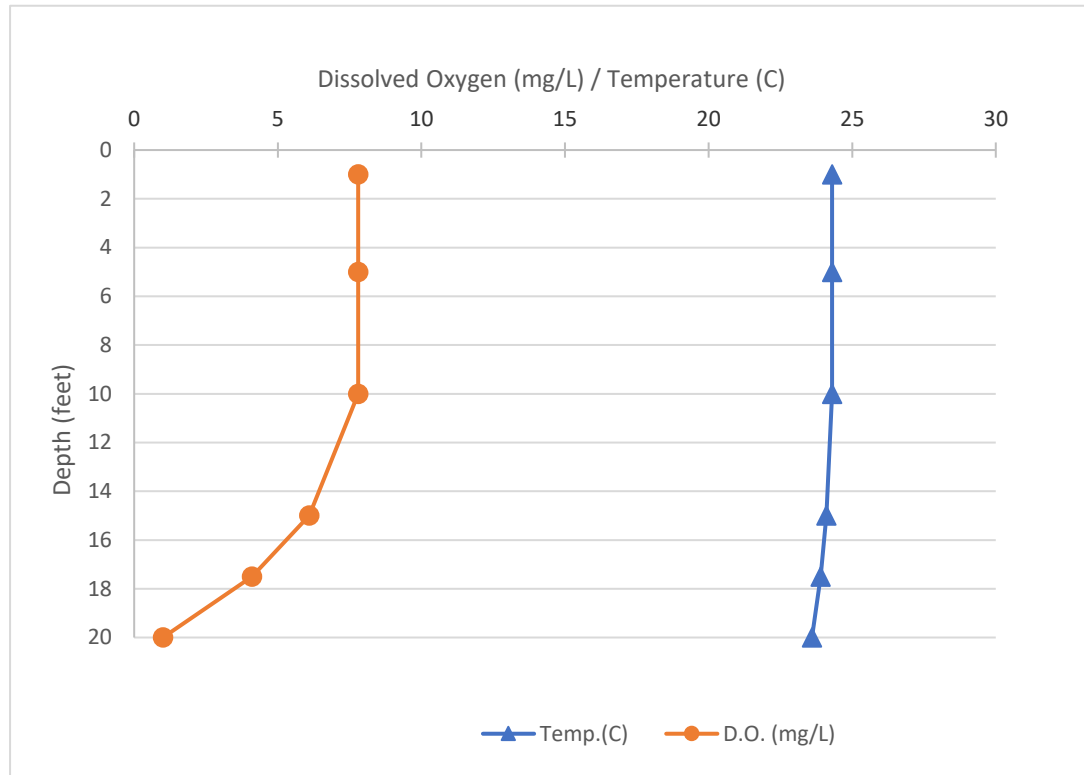
8/15/2019

Dissolved Oxygen and Temperature Profile

Depth (ft)	Temp.(C)	D.O. (mg/L)
1	24.3	7.8
5	24.3	7.8
10	24.3	7.8
15	24.1	6.1
17.5	23.9	4.1
20	23.6	1

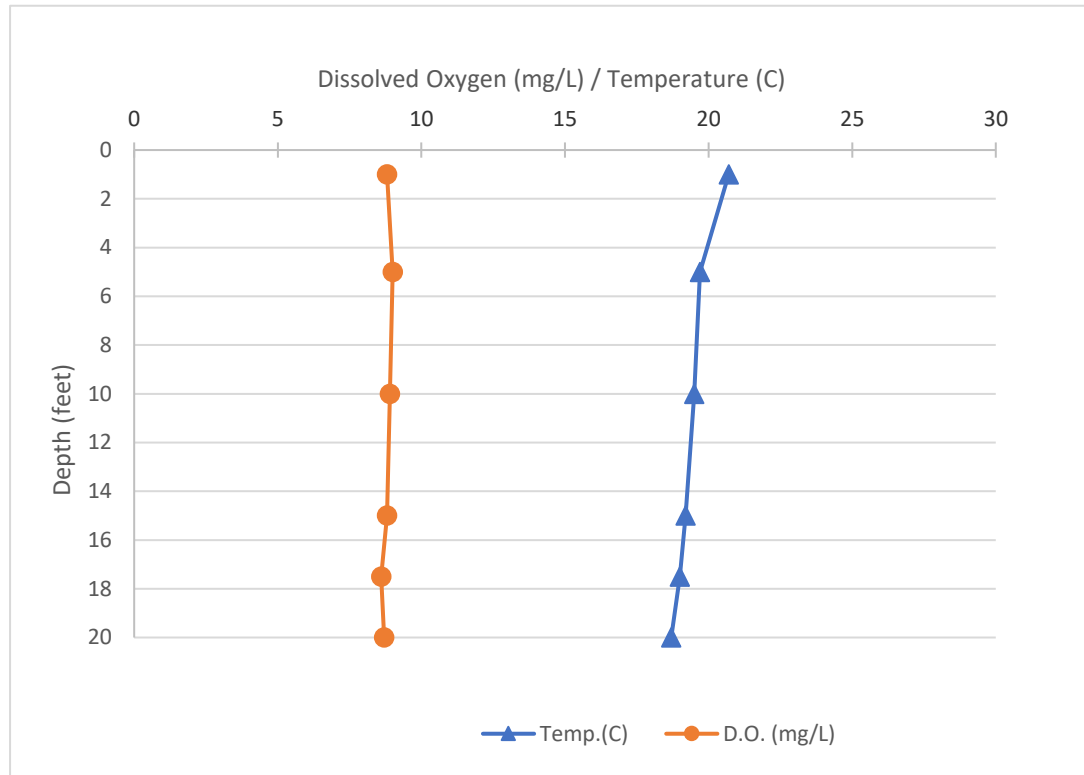
9/5/2019

Dissolved Oxygen and Temperature Profile

Depth (ft)	Temp.(C)	D.O. (mg/L)
1	20.7	8.8
5	19.7	9
10	19.5	8.9
15	19.2	8.8
17.5	19	8.6
20	18.7	8.7
